Ref.No.: HZDS97-03, Issued Date:Aug, 1997

## Improved coupling joint for driving shaft of cyl. oil lubricator

Engine Type : K/L/S 50-80MC(E)

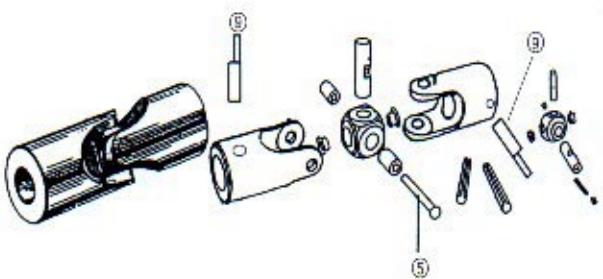
Recently, some accidents were reported from ships fitted K/L/S-MC type engine in which the pin (⑤ or ⑨) for universal joint had broken caused by wear.

Possible causes for this troubles are considered to be:

- Thermal expansion of cylinder frame
- Lack of lubricant
- Misalignment of driving shaft

Original one (universal joint)

It is recommended to check the wear condition of the subject universal joints on your engine(s).

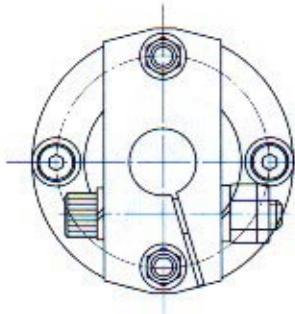
Improved one(plate-spring type)

As a countermeasure hereafter we introduce the joint of plate-spring type. Please consider to adopt the new type joint for safety.
