Ref. No.: HZDS97-06, Issued Date: Sep, 1997

Grinding-off limit of exhaust valve seat

Engine Type : K/L/S-MC(E)

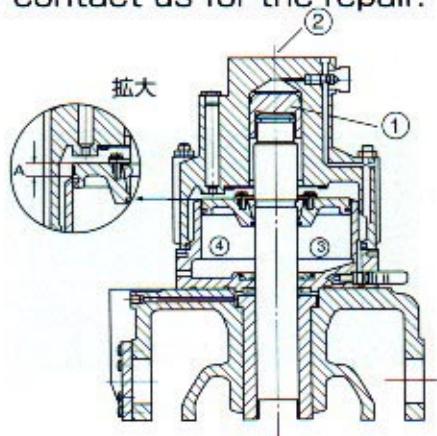
Recently, clash accidents were reported between top of the piston ① and oil cylinder ② and between disc ③ for conical ring and disc ④ on oil cylinder. (Refer to the figure shown the following)

This mishap resulted from excessive grinding-off of the valve seats.

As well known, grinding-off limit is 2 mm for valve spindle seat and bottom piece seat, respectively (total 4 mm). (Refer to Instruction Book Vol. II, 908-2)

Original	MAX
50MC(E)	1.3	5.0
60MC(E)	1.2	5.0
70MC(E)	2.0	5.5
80MC(E)	1.8	5.5

The excessive grinding-off leads to mishap as mentioned above, therefore it is absolutely necessary to measure "A" before re-assembling.

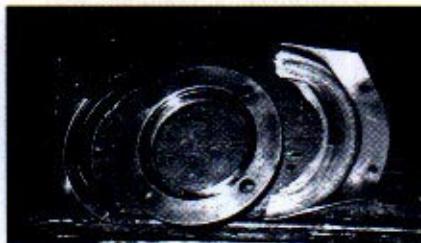
Broken disc on oil cylinder
